**Pier 4 Phase 1
Removal Action Project**

**Time Critical Removal
Action Completion Report**

Port of Tacoma
P.O. Box 1837
Tacoma, Washington 98401

July 2016

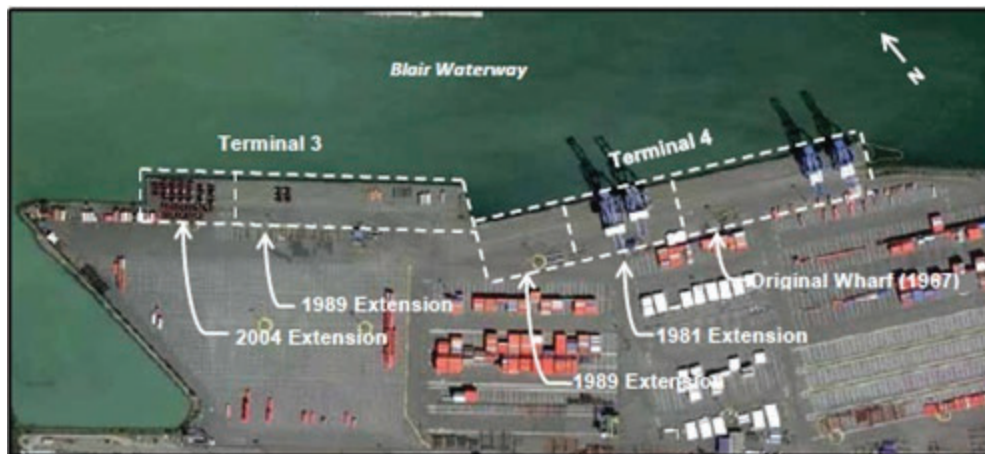
Photograph 1. Aerial view of Husky Terminal and dates of construction (Cardno TEC et al. 2012)

Pier 4 was constructed over a period of years starting in 1967 and ending in 1989. In 1967, the original wharf was constructed from pile Bents 35 through 76 at the south end of the pier, as shown in Photograph 1. In 1981, the pier was expanded from Bent 35 through 20 in the Pier 4 Extension Project, and Bents 1 through 20 were later added in 1989 as part of the Terminal 3 and 4 Wharf Construction Project (Cardno TEC et al. 2012).

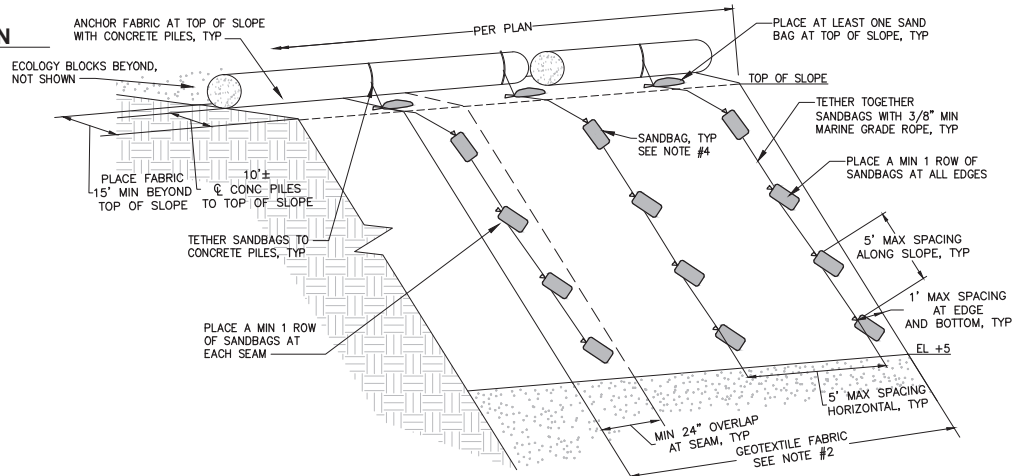
Figure 5.1
Temporary Slope
Stabilization Measures

SHORELINE PROTECTION PLAN

SHORELINE PROTECTION ISOMETRIC

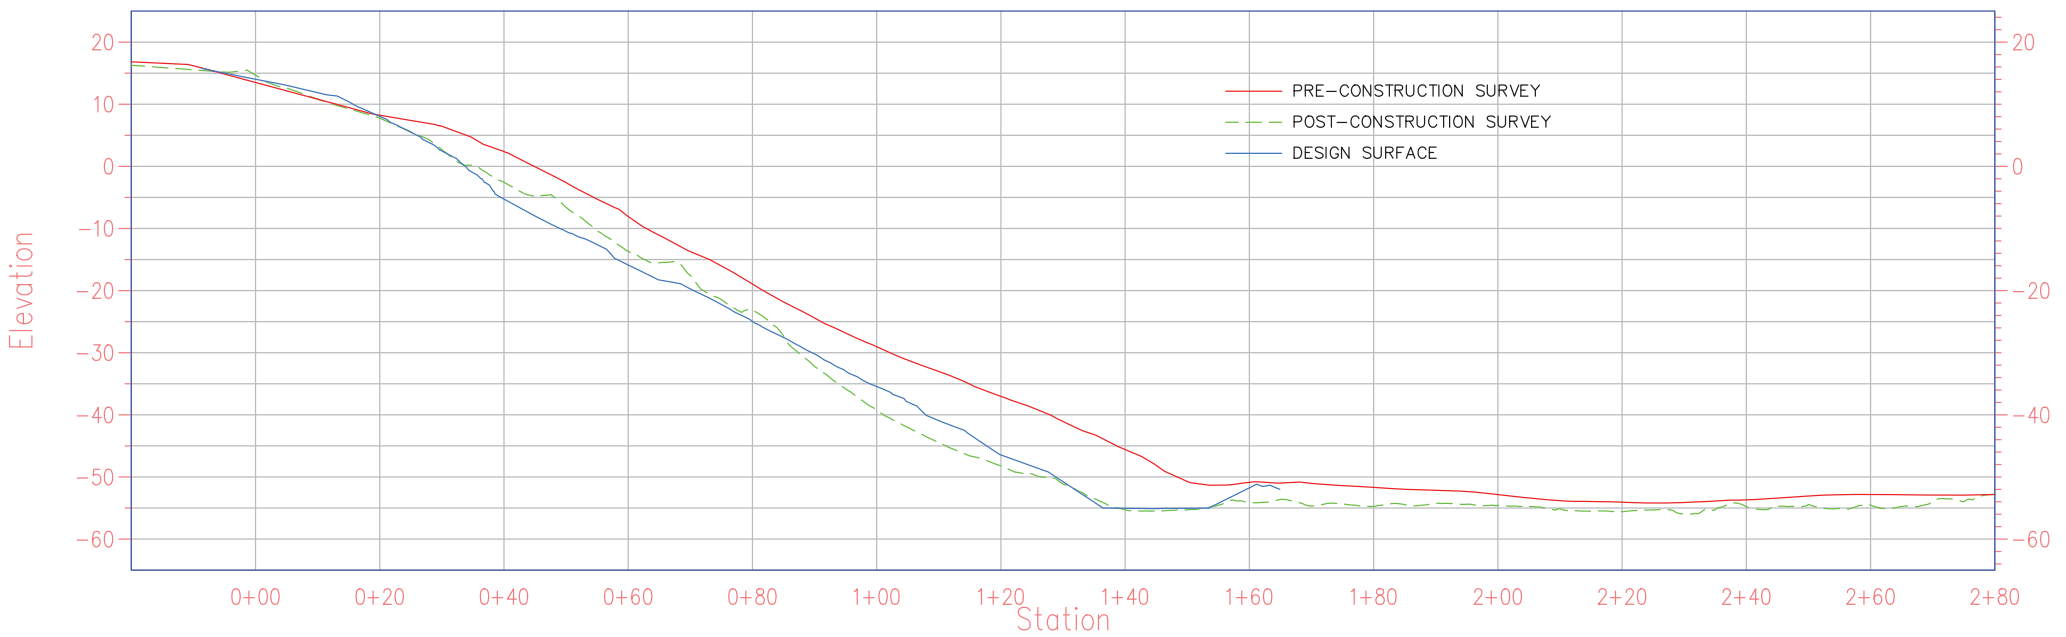
Figure 5.5
Dredge Section 1+00

THIS SURFACE COMPARISON CROSS SECTION WAS COMPILED FROM DATA OBTAINED FROM THE CONSTRUCTION DESIGN DRAWINGS PREPARED BY KPFF AND BATHYMETRIC SURVEY INFORMATION PROVIDED BY THE CONTRACTOR.

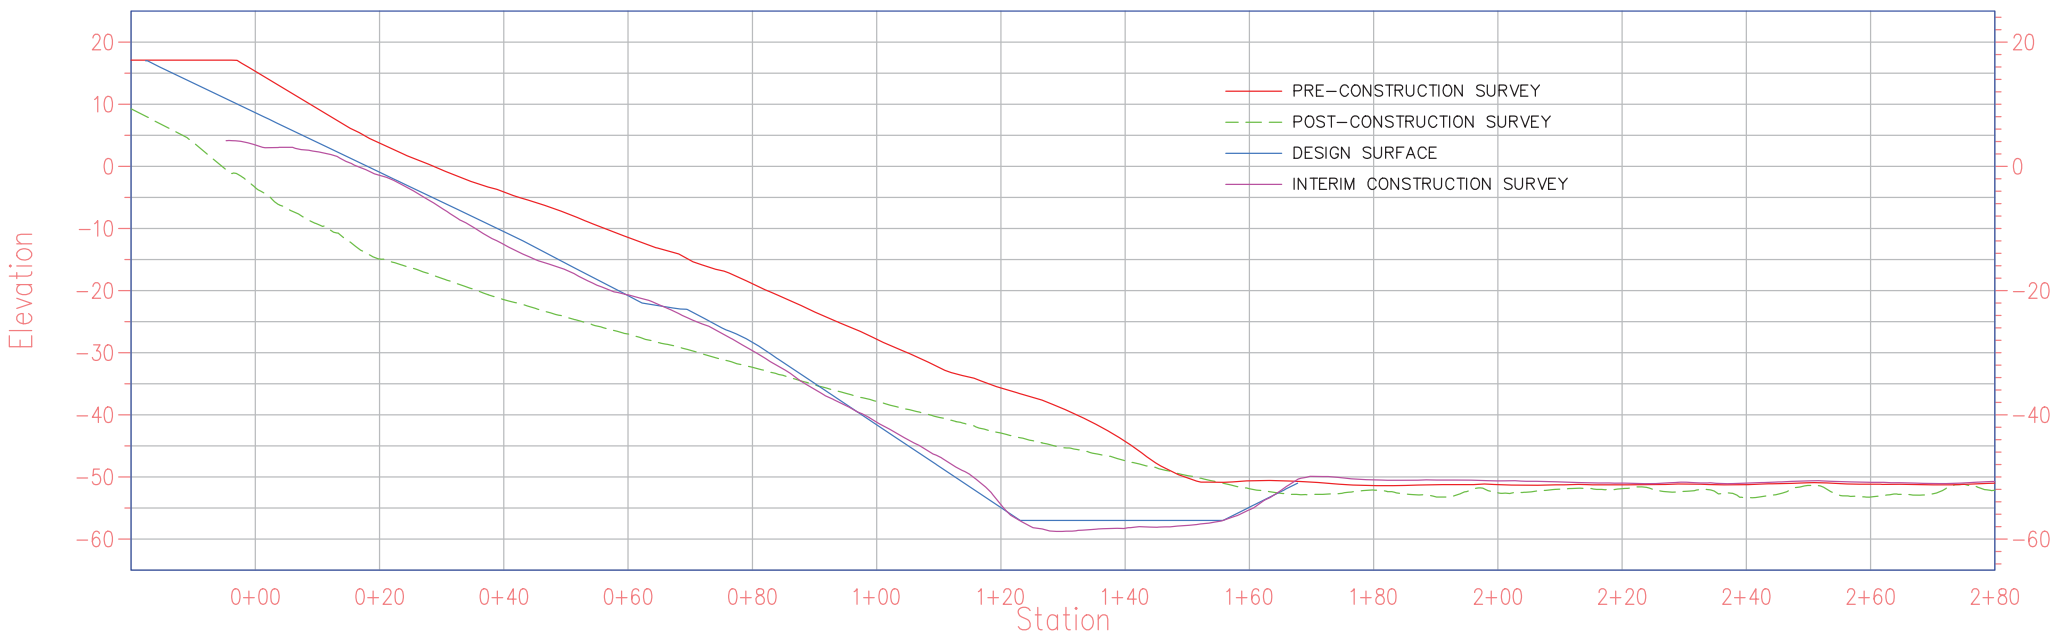
Figure 5.6
Dredge Section 3+00

THIS SURFACE COMPARISON CROSS SECTION WAS COMPILED FROM DATA OBTAINED FROM THE CONSTRUCTION DESIGN DRAWINGS PREPARED BY KPFF AND BATHYMETRIC SURVEY INFORMATION PROVIDED BY THE CONTRACTOR.

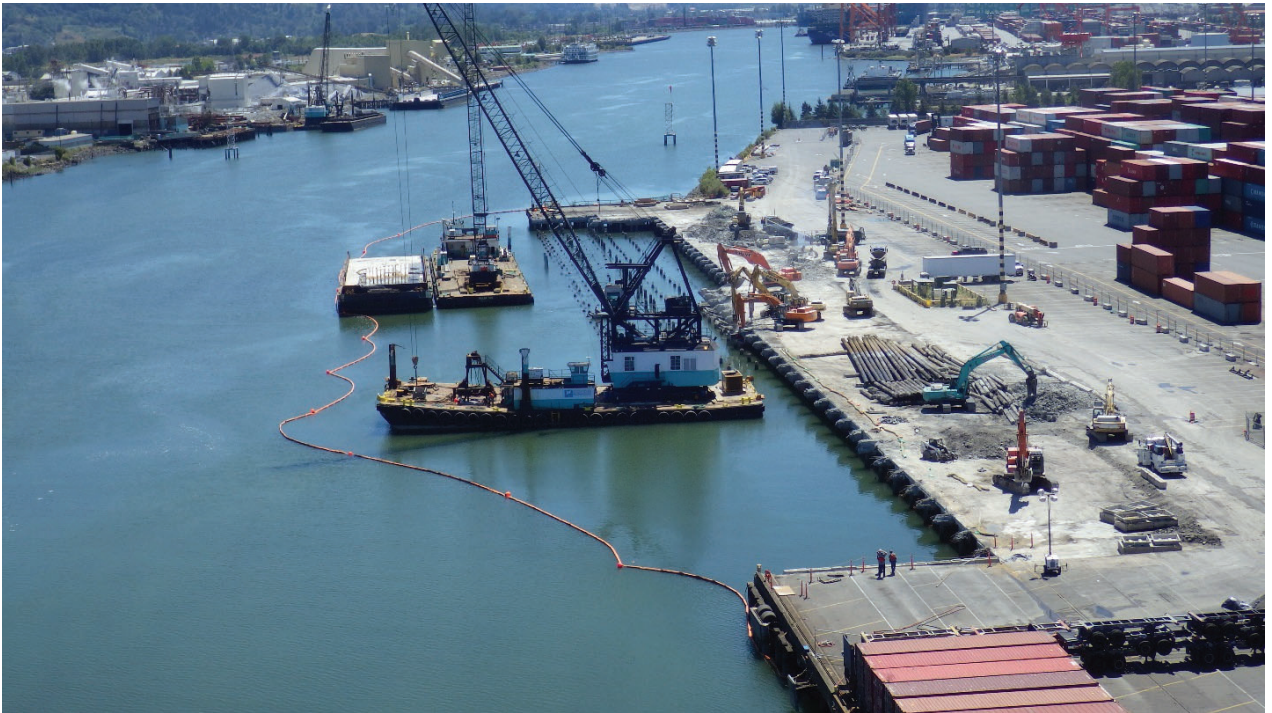
Photograph 1. Temporary floating boom and pile pulling.

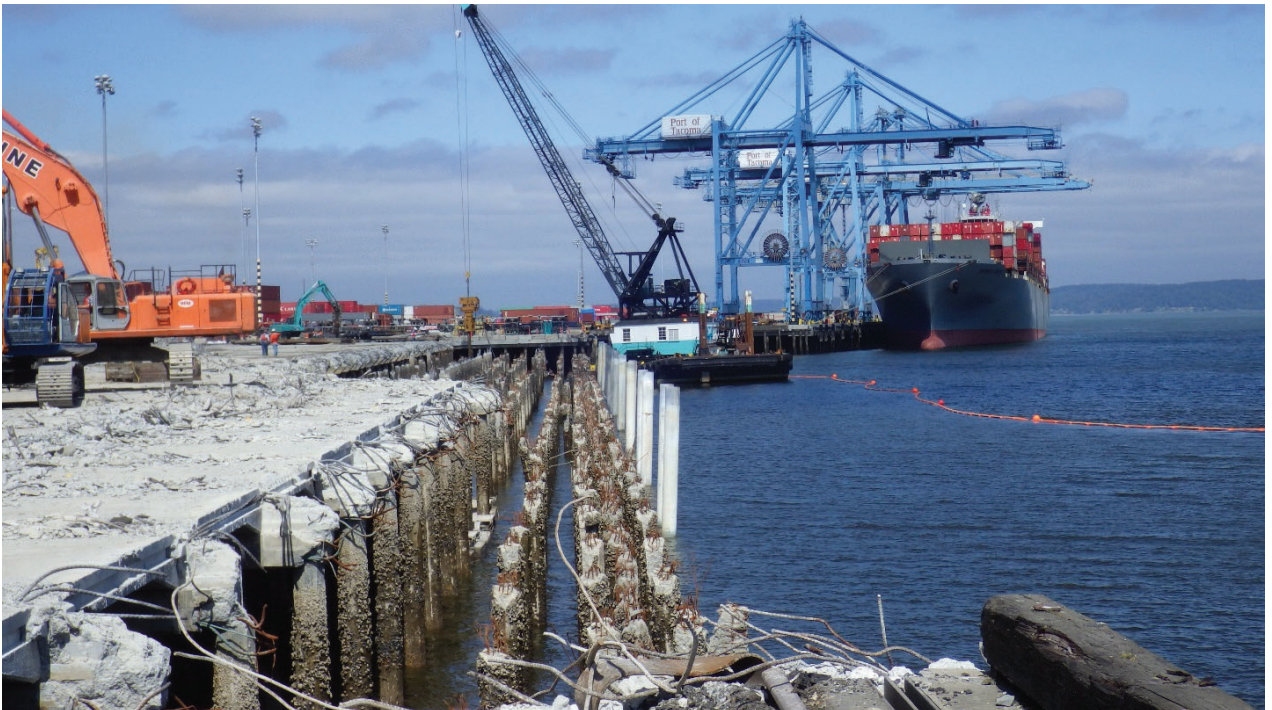
Photograph 2. Demolition of the pier.

Deck asphalt removal began on May 1, 2015. On May 11, 2015, Rhine began demolition of the bull rail, pier deck panels, and pile caps, starting from the north and working to the south (Appendix A, Photograph 2). All material was stockpiled on the pier for eventual off-site disposal or recycling (Appendix A, Photograph 3). Ballast removal also started on May 11, 2015. During removal of ballast, Rhine observed oil staining within the excavated material from the southern portion of the pier (Appendix A, Photograph 4). The Port tested the material to determine the appropriate disposal requirements. Results indicated that oil-range TPH were present (refer to Appendix B). The Port and Orion determined that additional samples should be taken because the initial sample was taken from surface material and the discoloration increased with depth during excavation. The second set of analytical results indicated that a portion of the material contained oil-range TPH. The Port directed Orion to dispose of the contaminated material, and 1,979 tons of ballast were taken to LRI. The Port also tested the ballast from the northern portion of the pier. The analytical results indicated that this ballast did not contain TPH.

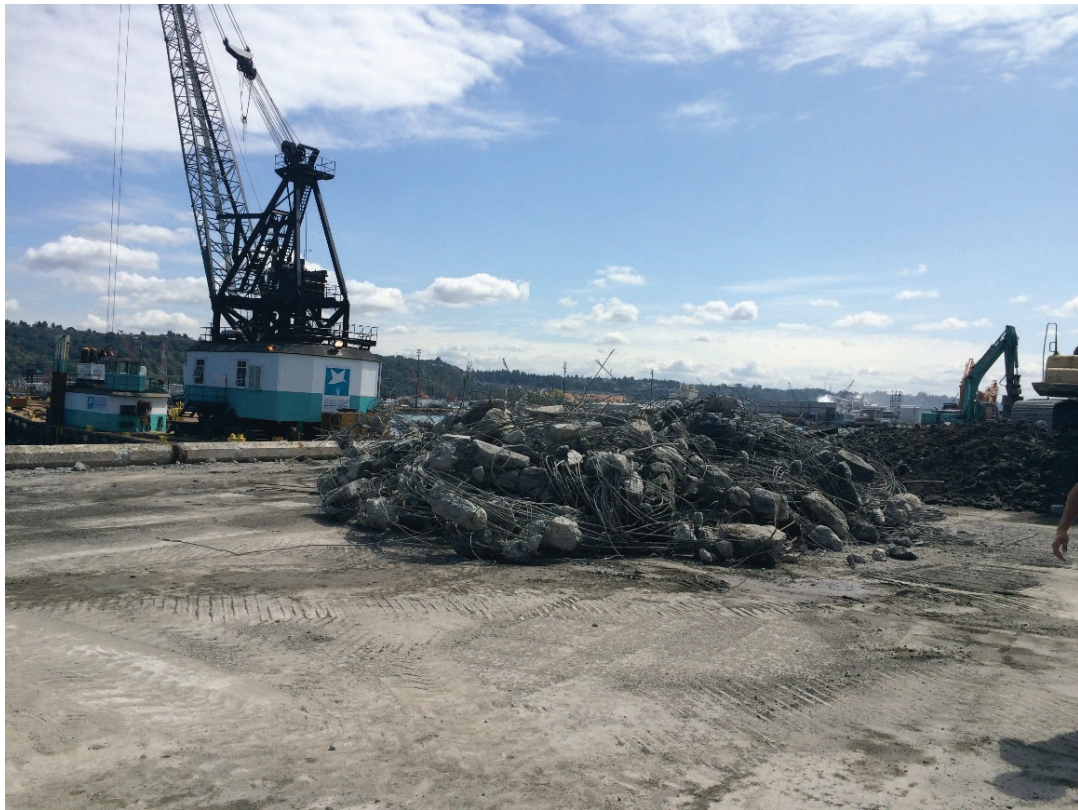
Photograph 3. Temporary stockpile of concrete and rebar.

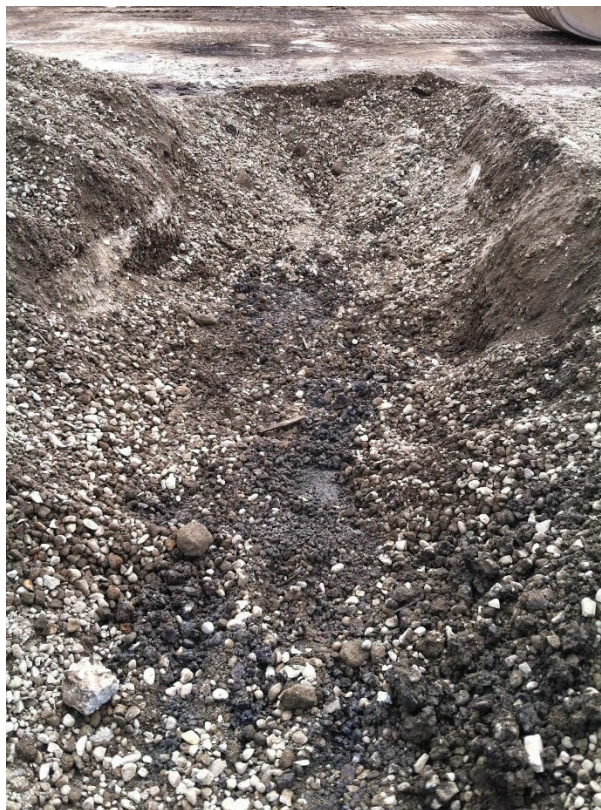
Photograph 4. Oil-impacted ballast.

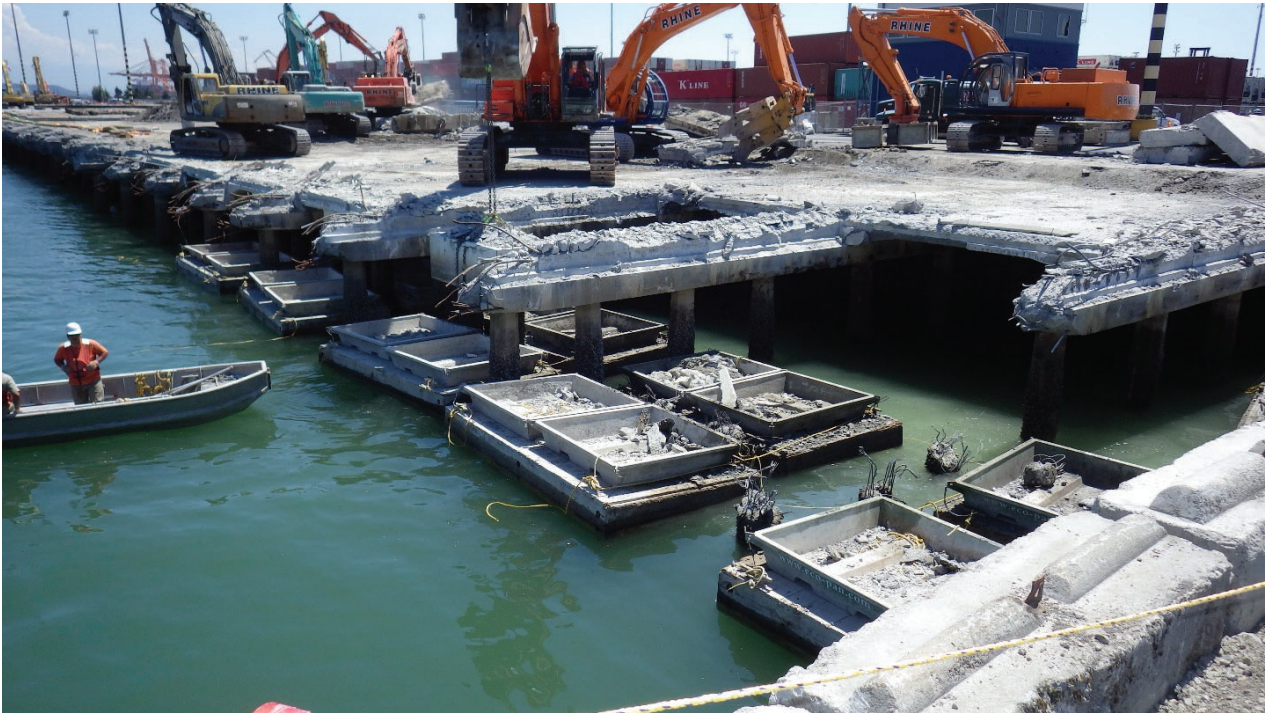
Photograph 5. Debris catching floats under deck demolition activities.

During deck demolition, Orion noted pre-existing damage to some pilings. During removal of the deck panels, some piles became separated from the pile caps and fell into the waterway. Orion conducted a diver survey and no broken piles were observed above the sediment line. Per Orion's Demolition Plan, in order to prevent deck debris from falling into the waterway, Orion made debris catching floats out of wood that were placed under active removal areas and moved according to where demolition was occurring (Appendix A, Photograph 5). The floats were emptied as necessary to prevent overloading or spillage of debris into the water. In order to allow access to under pier areas for saw cutting and chipping, a combination of floats and friction collar-supported access platforms were used. Any material on the floats was maintained so that debris was never submerged during a rising tide.

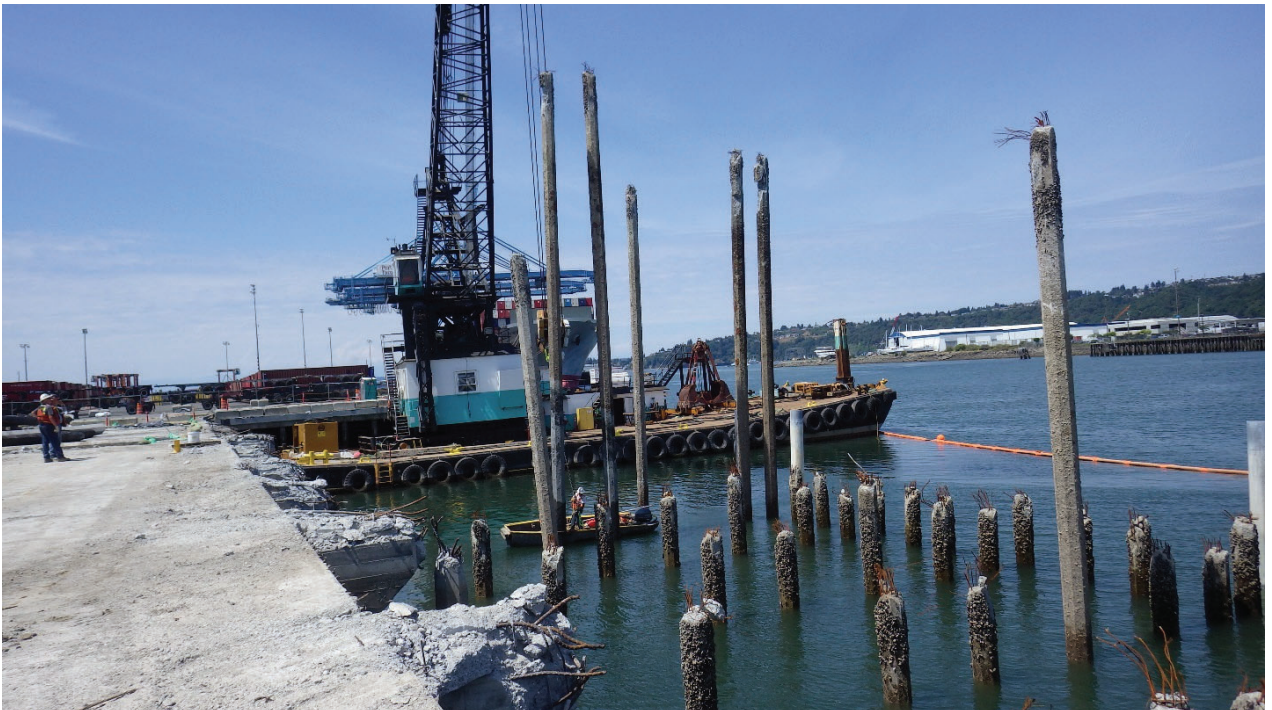
Photograph 6. Piles being removed and transferred to shore.

Piles were first extracted using a vibratory hammer (Appendix A, Photographs 6 and 7). Then, the piles were attached to rigging cables attached to the derrick barge and transported to shore where they were placed in a processing area to be broken into smaller pieces for eventual off-site disposal or recycling, depending on the pile type.

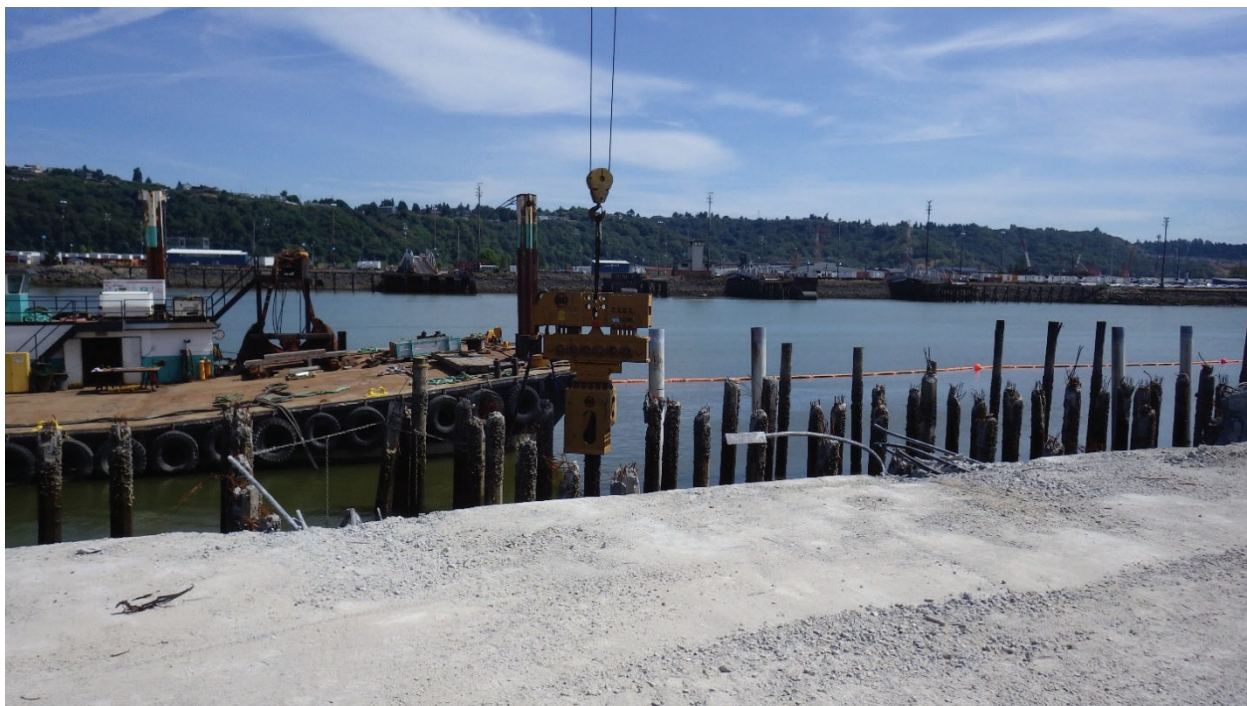
Photograph 7. Vibratory pile removal.

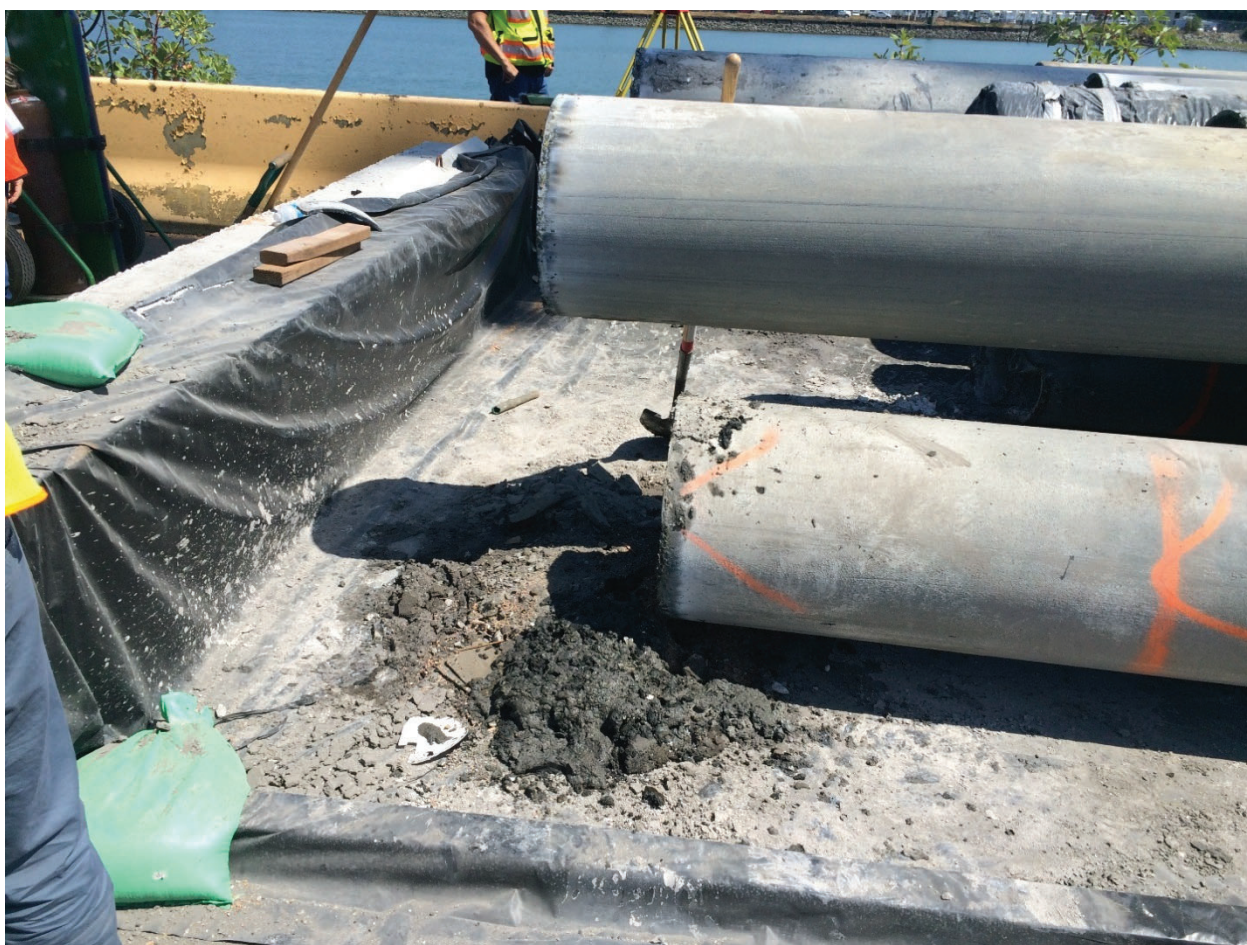
Photograph 8. Steel pipe piles with sediment.

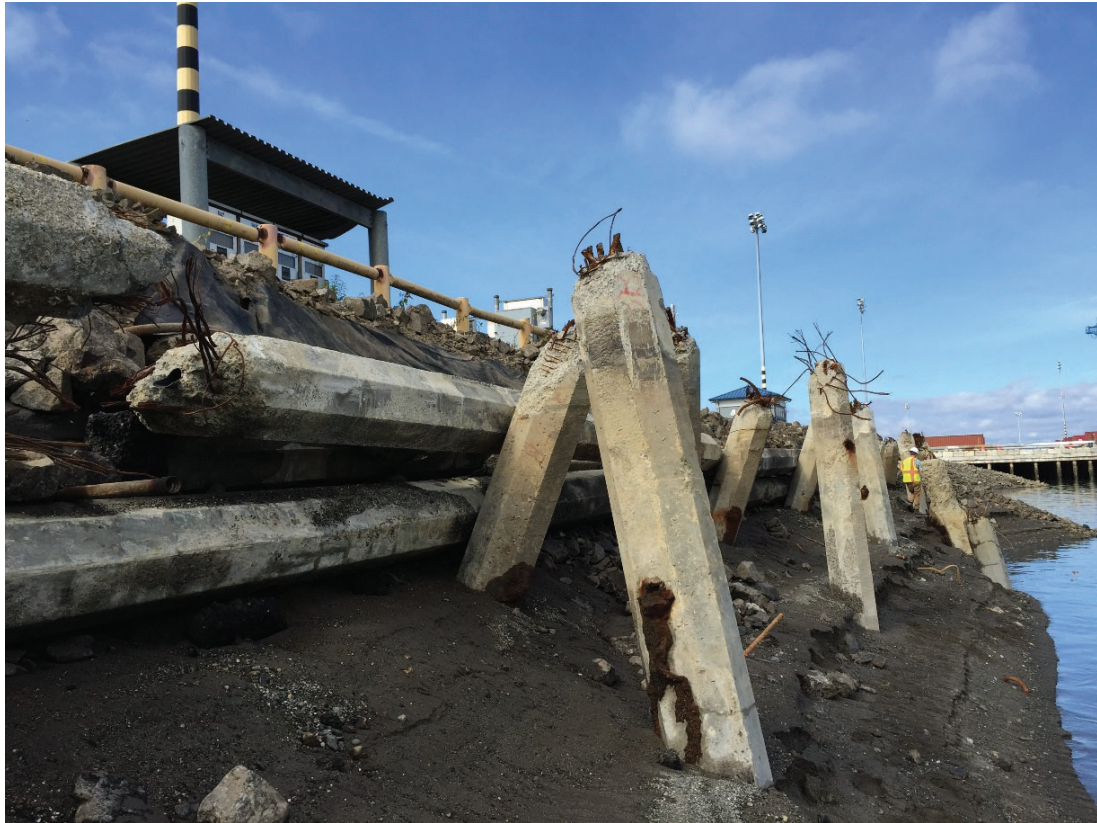
Photograph 9. Concrete pile remnants and in place piles for slope stabilization.

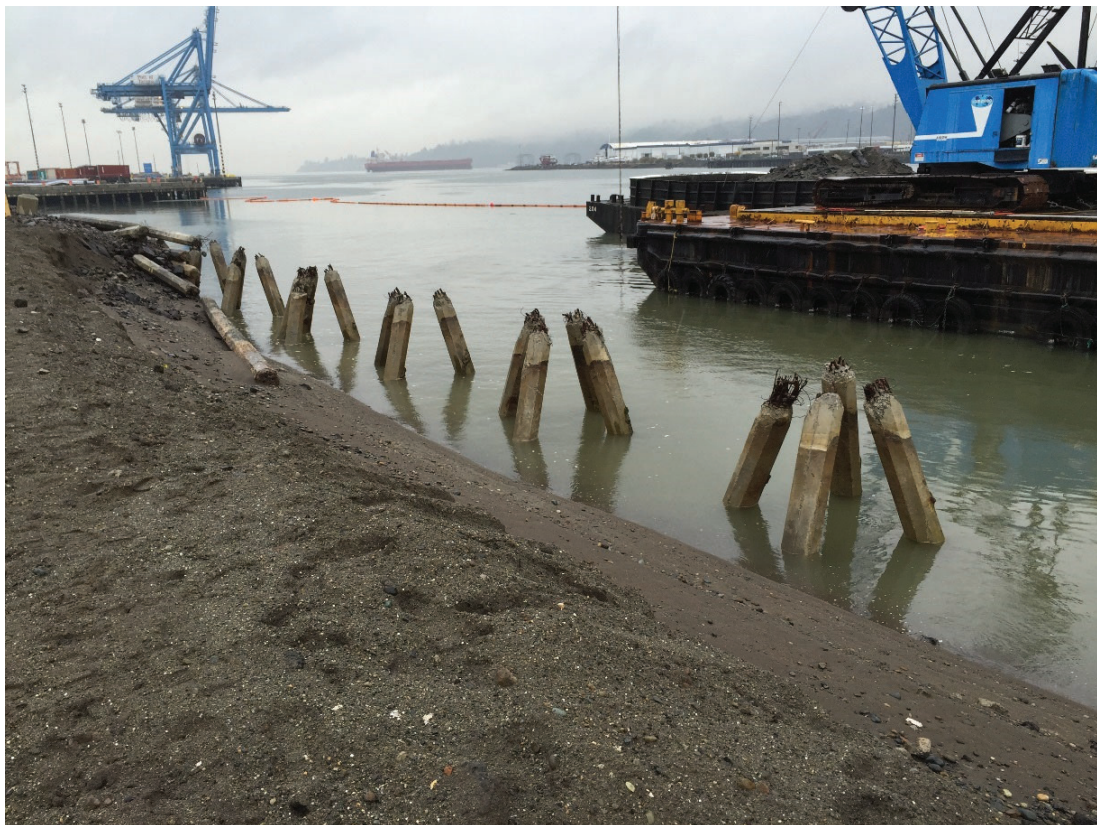
Photograph 10. Concrete piles left in place for slope stabilization.

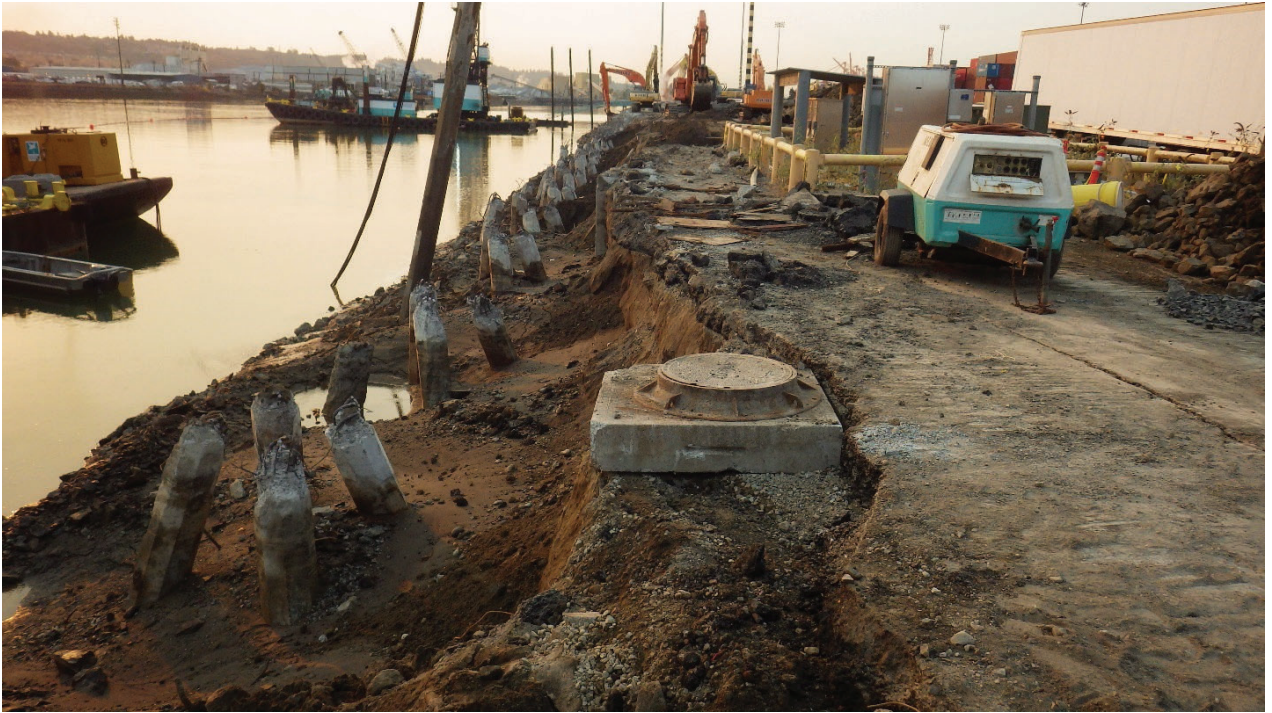
Photograph 11. In place concrete piles in front of substation.

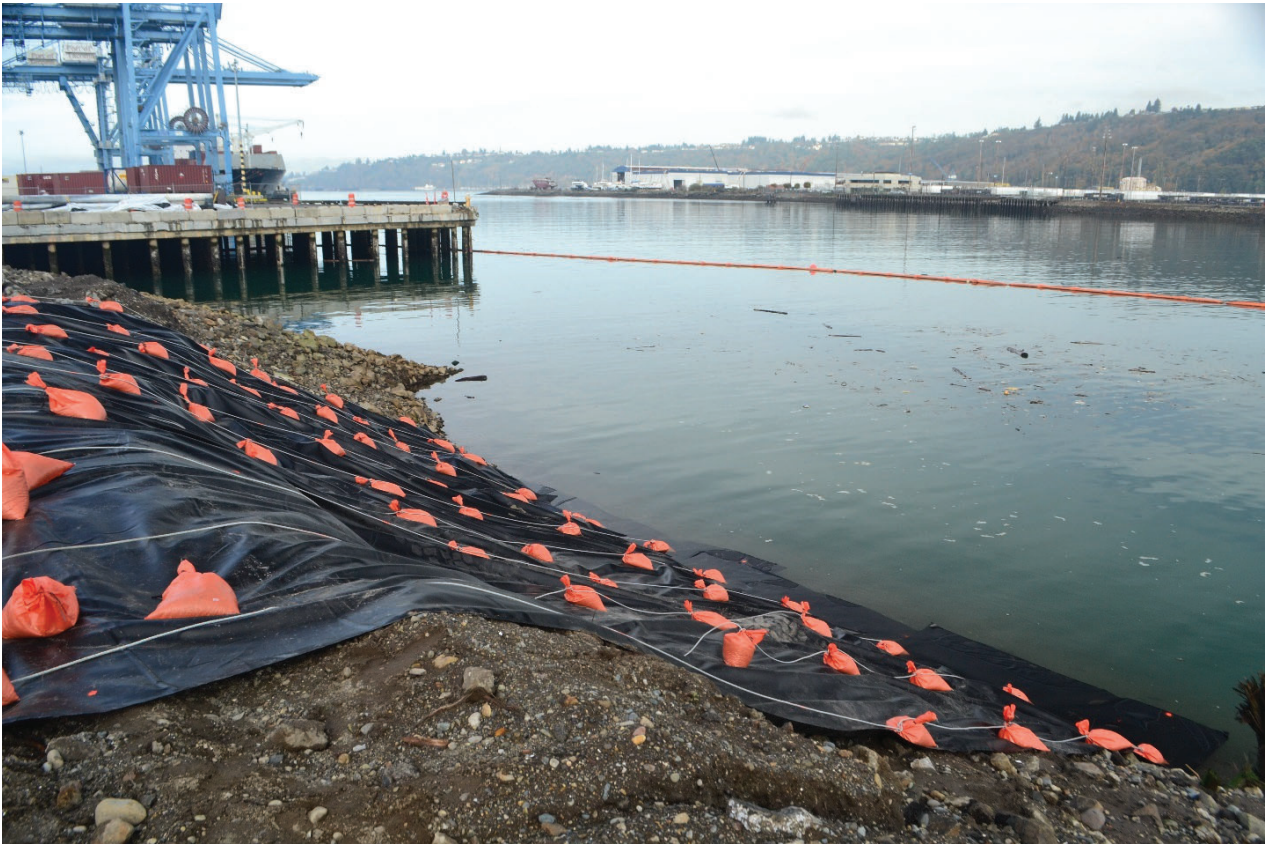
Photograph 12. Geotextile fabric and sand bags placed on slope for temporary erosion control.

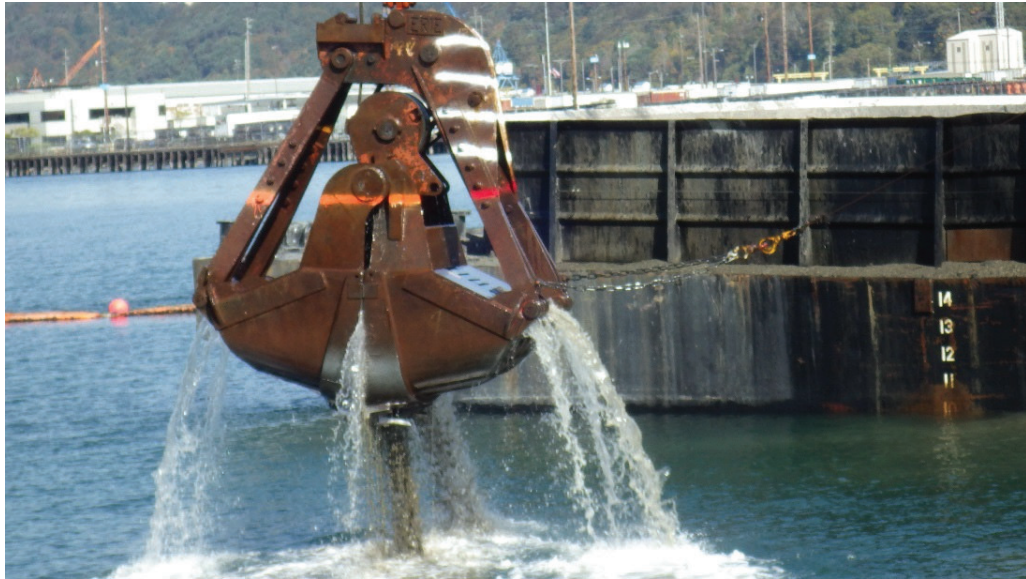
Photograph 13. Turbid water releasing from bucket during dredging.

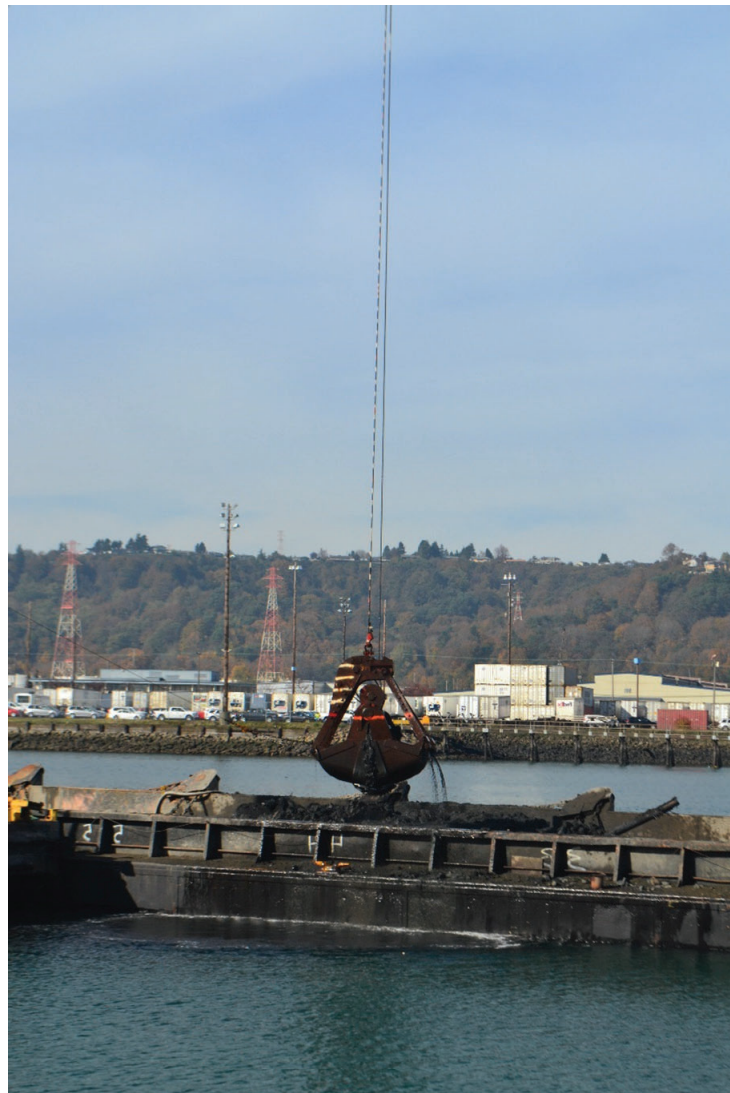
Photograph 14. Closed bucket during dredging.

Per the RAWP, the digging bucket was modified with a steel-fabricated “top hat” in order to close off the top of the dredge bowls to minimize sediment loss as the bucket was raised through the water column. The top hat was constructed between September 2 and September 11, 2015. To prepare for contaminated dredging, leak tests were conducted on the barges prior to use and all leaks observed were fixed prior to barge use.

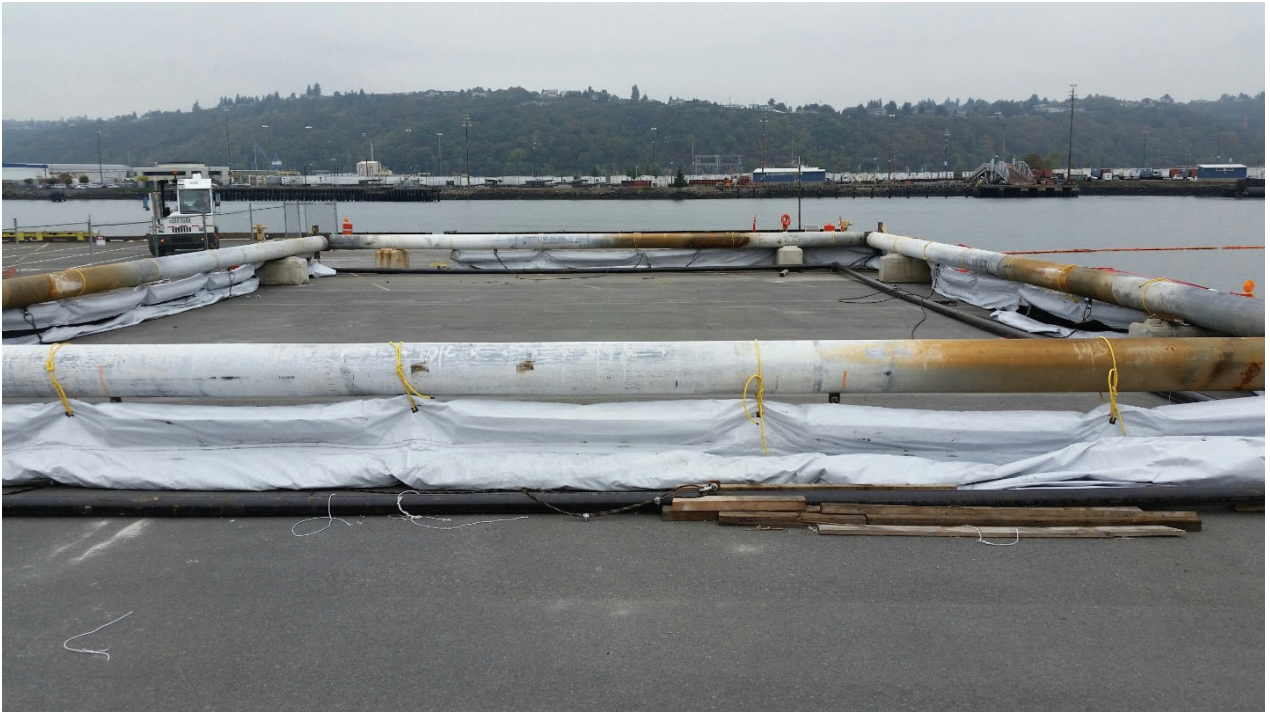
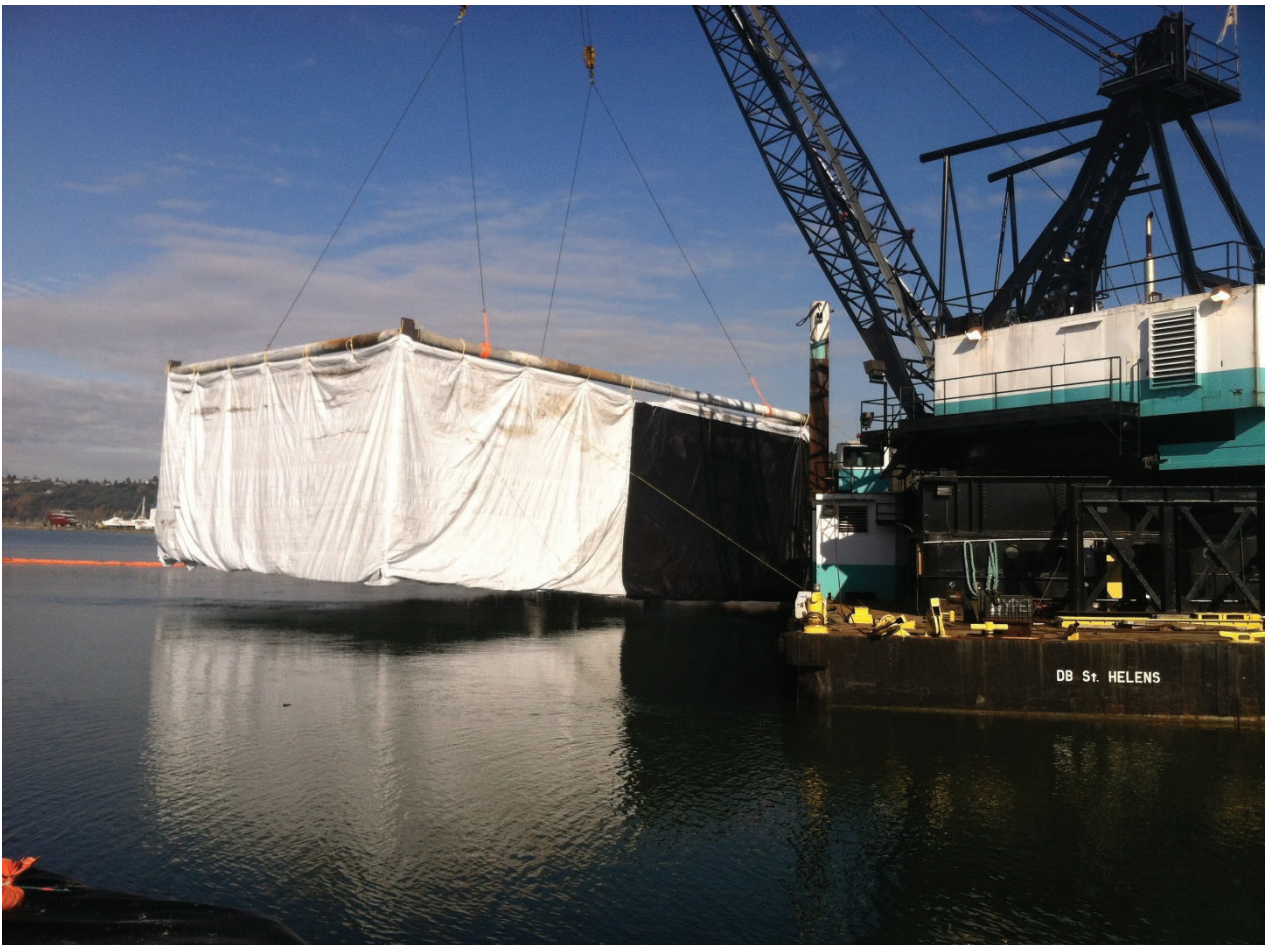
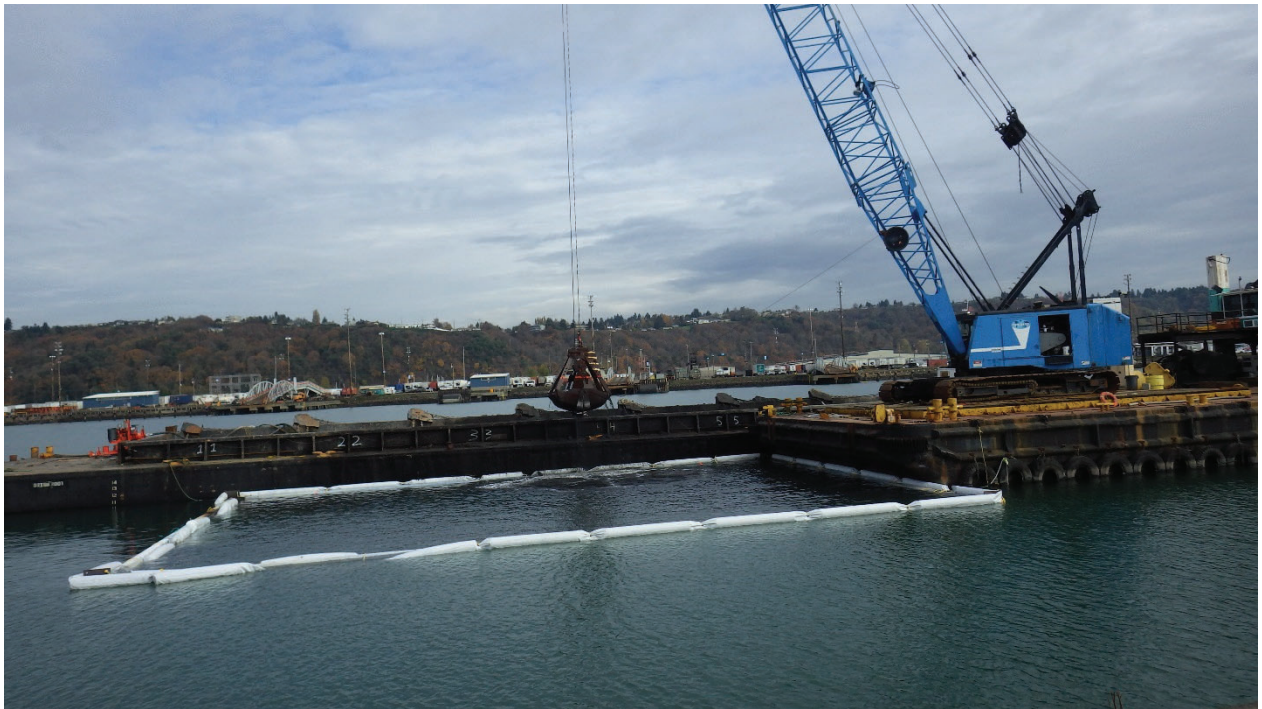
Photograph 15. Floating boom-supported turbidity curtain prior to deployment.

Photograph 16. Floating boom-supported turbidity curtain during deployment.

Photograph 17. Floating boom-supported turbidity curtain in use during hot spot dredging.

- **Evaluation of dredging BMPs in context with site conditions and other regional projects allowed for optimization of site-specific construction methods.** The ability to analyze common dredge BMPs, within the context of site conditions, and present the predicted effectiveness of the BMPs allowed for the joint identification of BMPs and construction methods that were tailored to the project. The project greatly benefited from lessons learned on other regional contaminated dredging projects. One example of this process was the use of a floating boom-supported silt curtain to protect water quality during hot spot dredging.

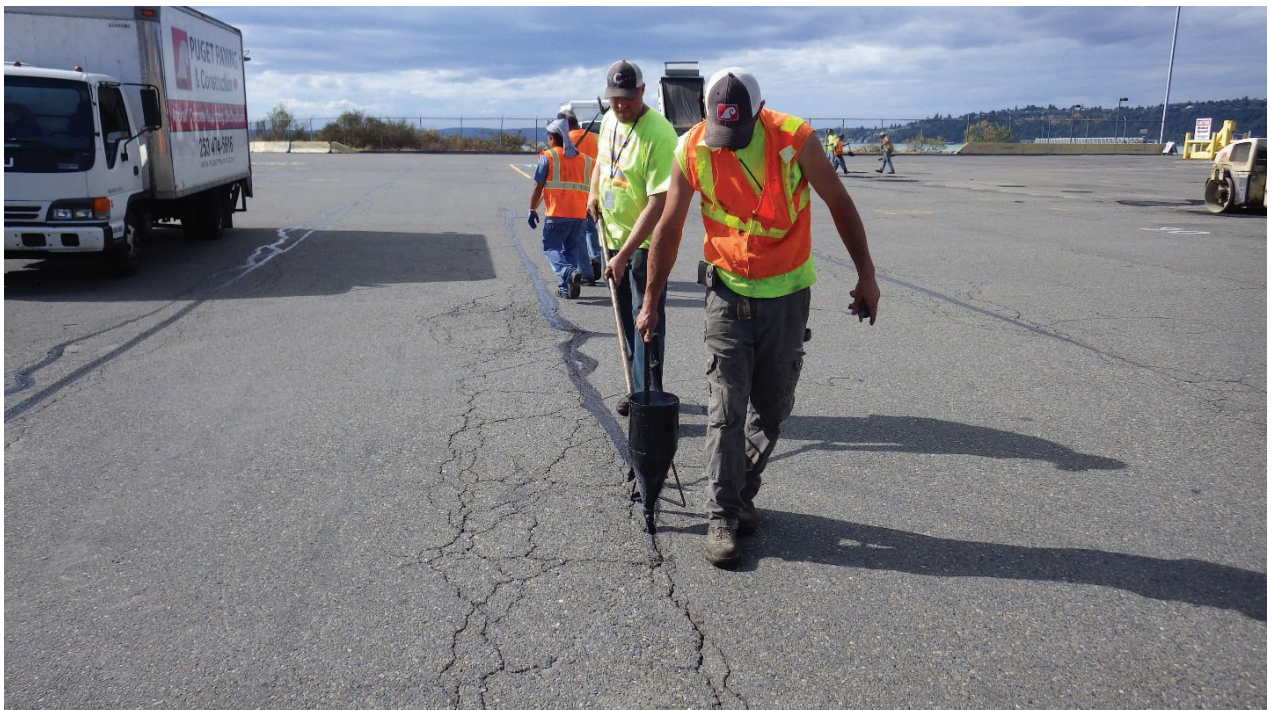
Photograph 18. Crack sealing at APM Terminals.

- **New Haul Routes.** APM Terminals designed a new route through the terminal to maximize safety, with ingress and egress off of two locations on Lincoln Avenue.
- **Crack and Catch Basin Sealing.** Per the RAWP, although APM Terminals is fully paved with asphalt 4 inches thick, any significant cracks needed to be sealed prior to starting the transload and dewatering activities and existing 4-inch deck drains needed to be plugged to prevent all process water and sediment from entering the Sitcum

Waterway during transload activities. From August 5 to 7, 2015, Puget Paving sealed cracks over approximately 3.75 acres of APM Terminals (Appendix A, Photograph 18).

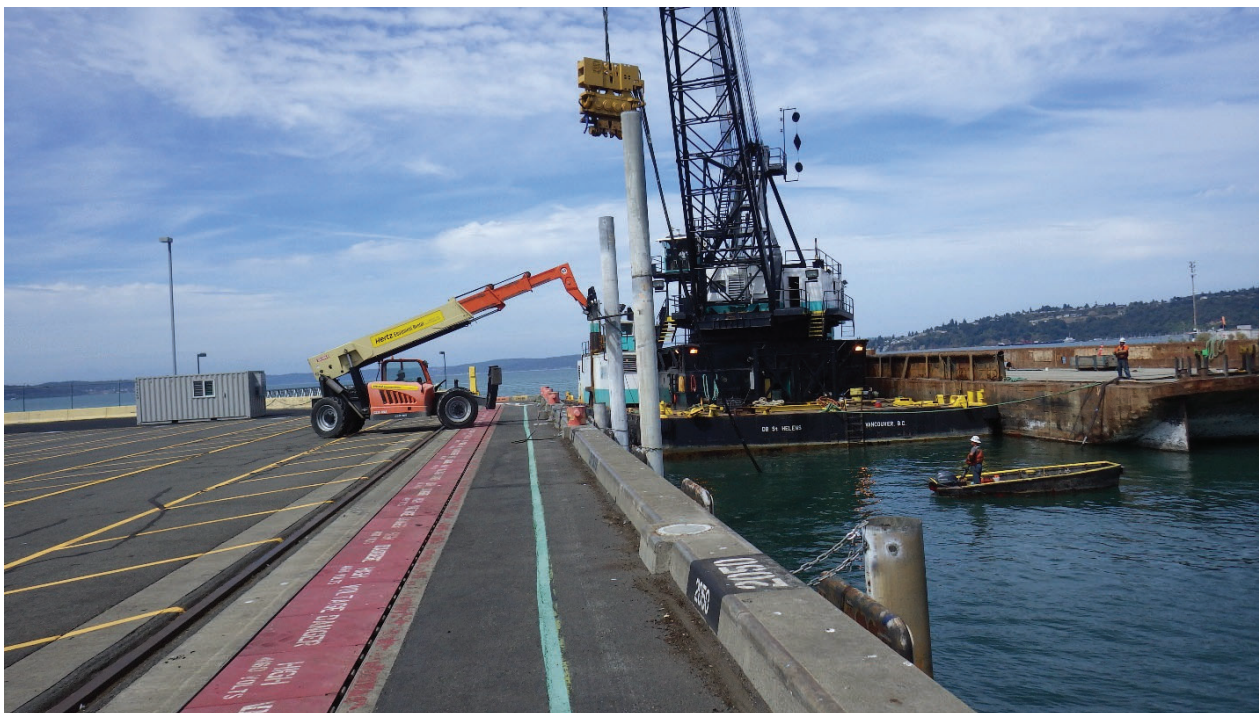
Photograph 19. Installation of temporary mooring steel piles at APM Terminals to protect the fender system.
